The HPX-1 CR System Built for NDT

The following presentation highlights the rigorous dust test performed on an HPX-1 system.

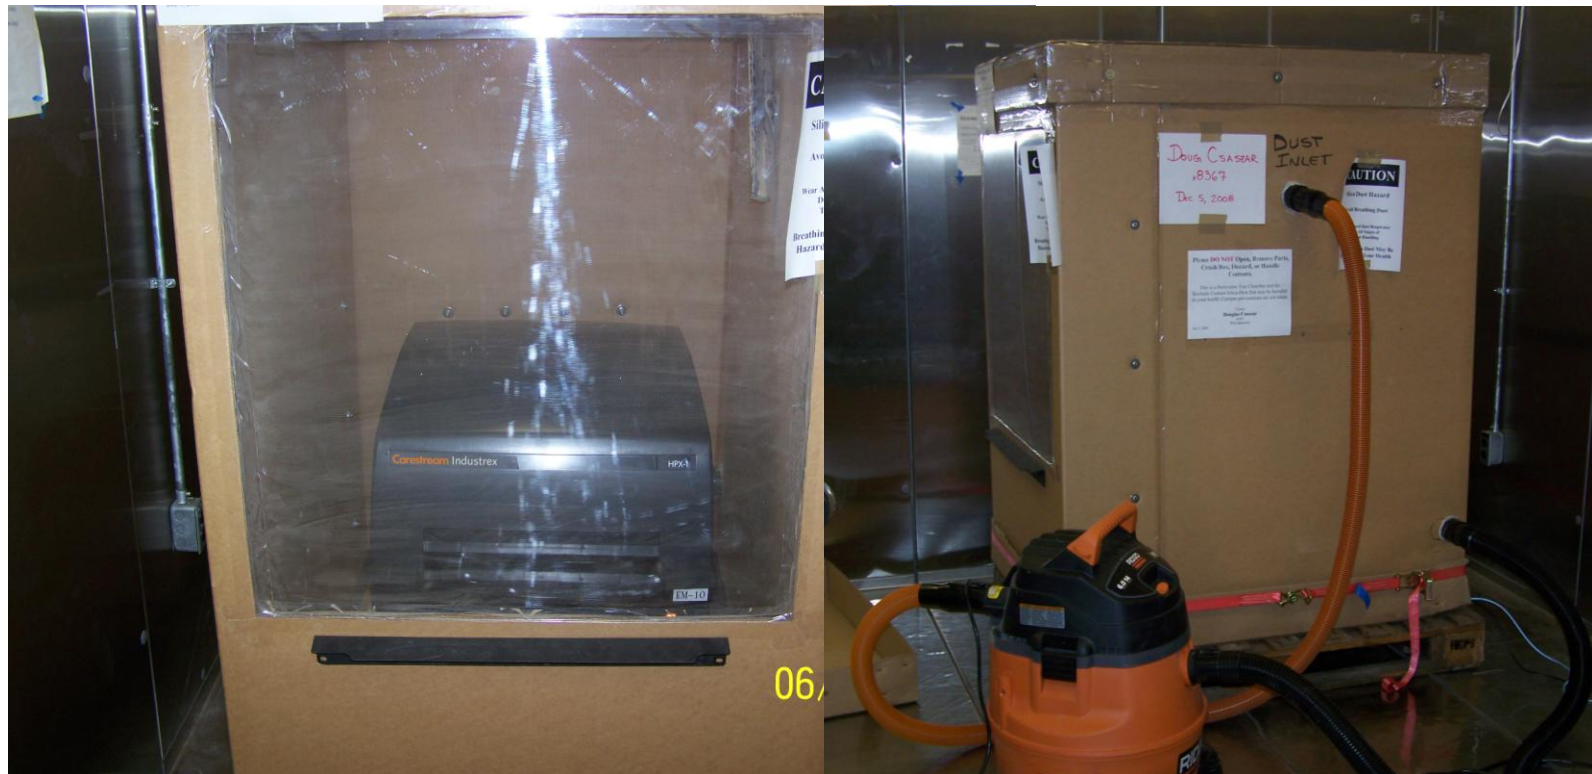
- A new HPX-1 was installed in a fabricated dust-test enclosure

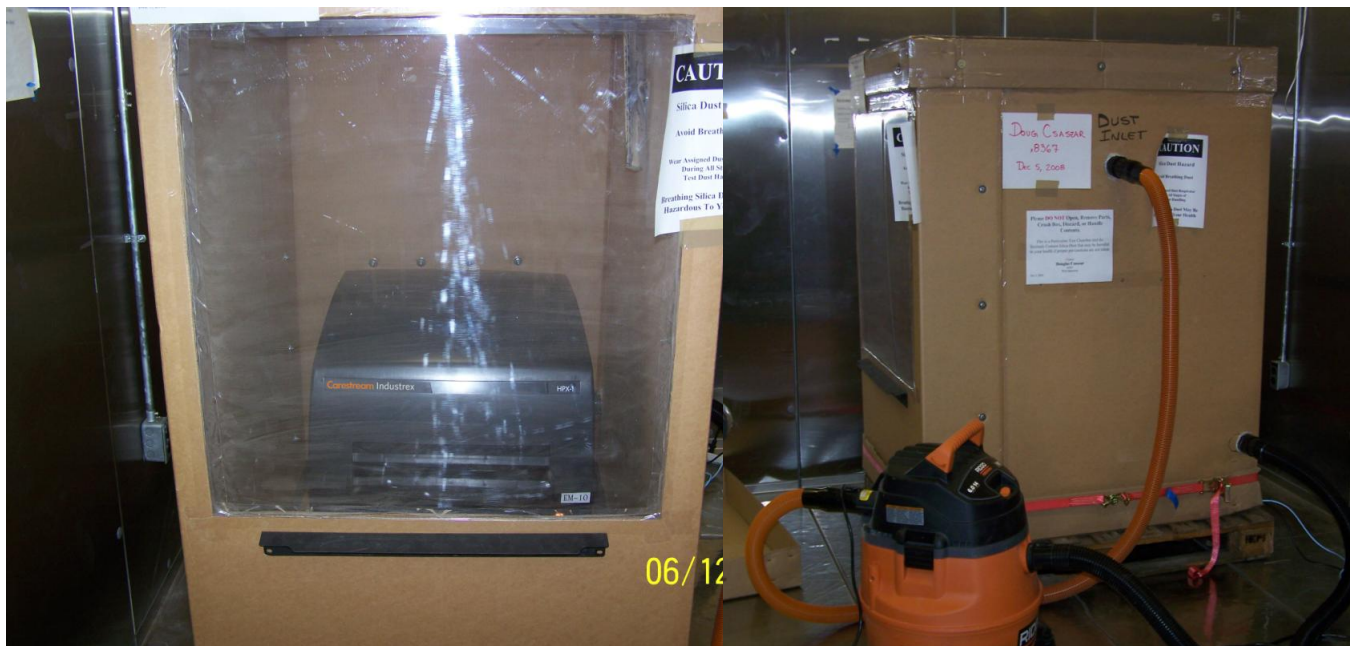
- 280 grams of Silica dust (particle size 0-180 μ m) was systematically injected into the chamber
- Each of the 100 injections measured 2.8 grams to ensure proper dispersion
- *This is DOUBLE the requirement of MIL STD 810-4 Test Method 510.4 Procedure III – Settled Dust!*

1. The HPX-1 stood up to twice the requirements of MIL STD 810-4 Test Method 510.4 Procedure III – Settled Dust

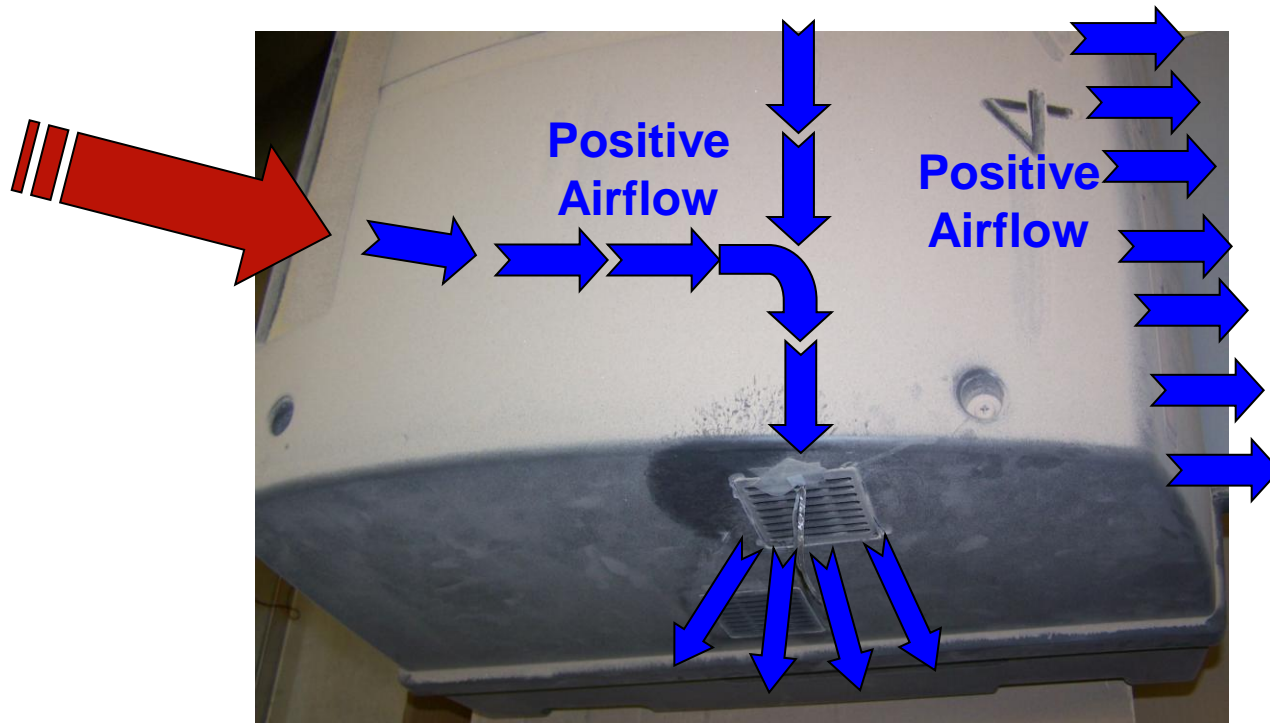
Multiple positive pressure fans and dust filters inside the HPX-1 keep dust, debris and contaminated air out of the system. *Even in the worse environments!*

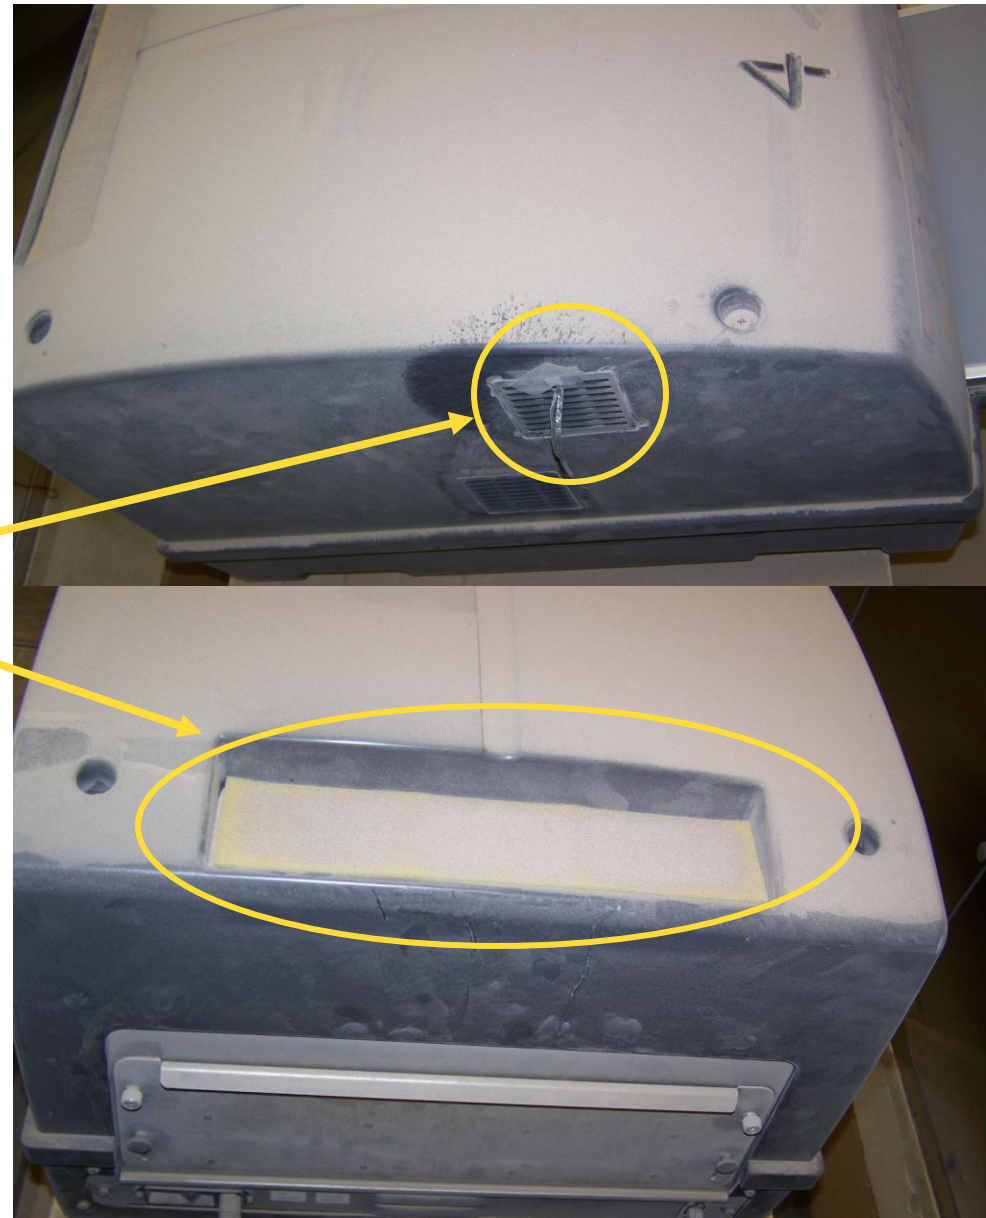
Exterior After

- At the end of the test the unit was completely covered in dust
- Multiple positive pressure fans and filters kept the dust, debris and contaminated air out of the system

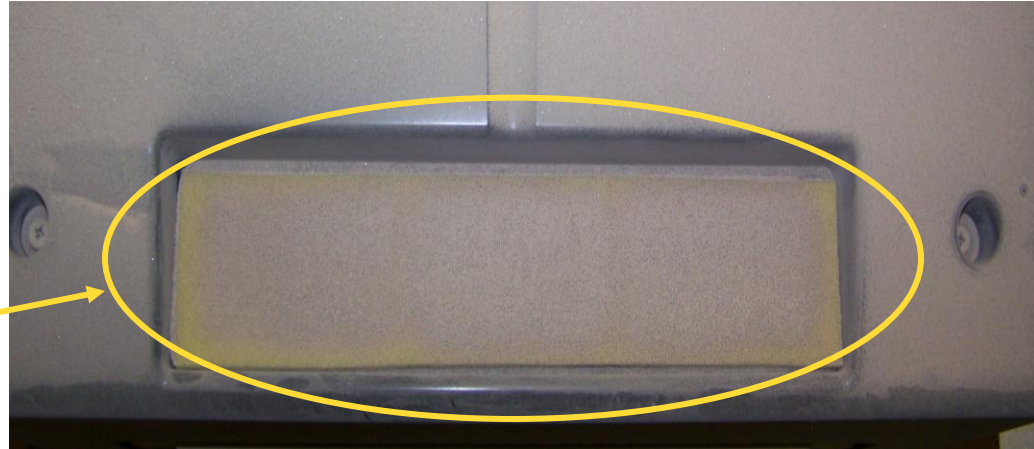
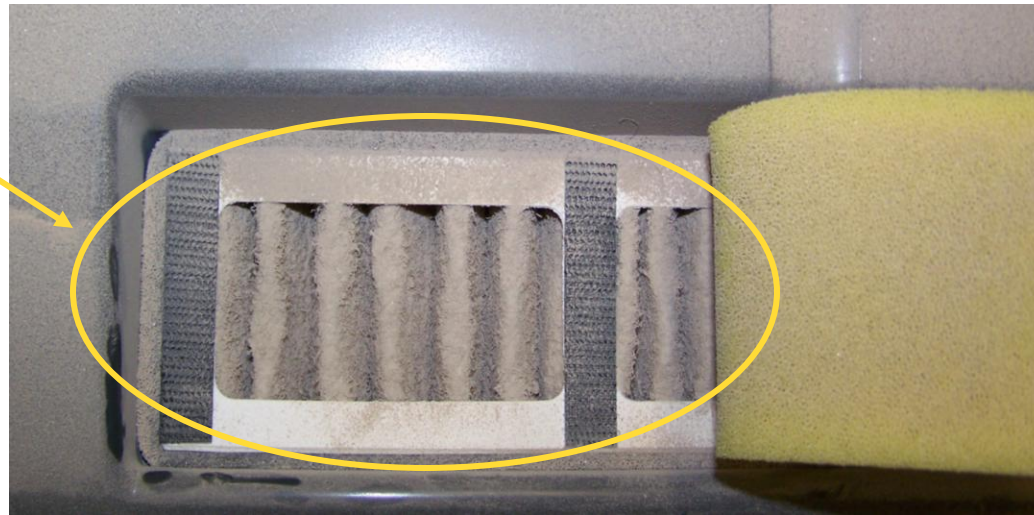
Exterior After

- Two independent levels of filtration provide twice the protection
- External filters effectively capture airborne contaminants before they were able to infiltrate the unit

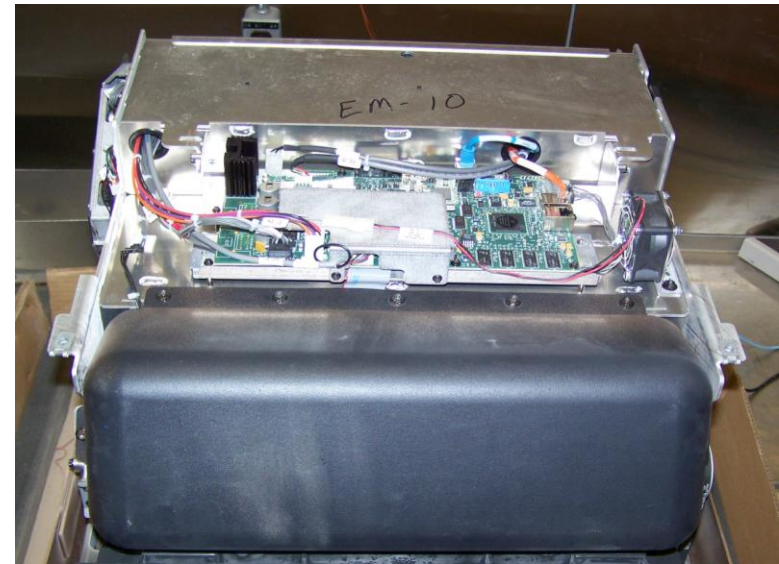
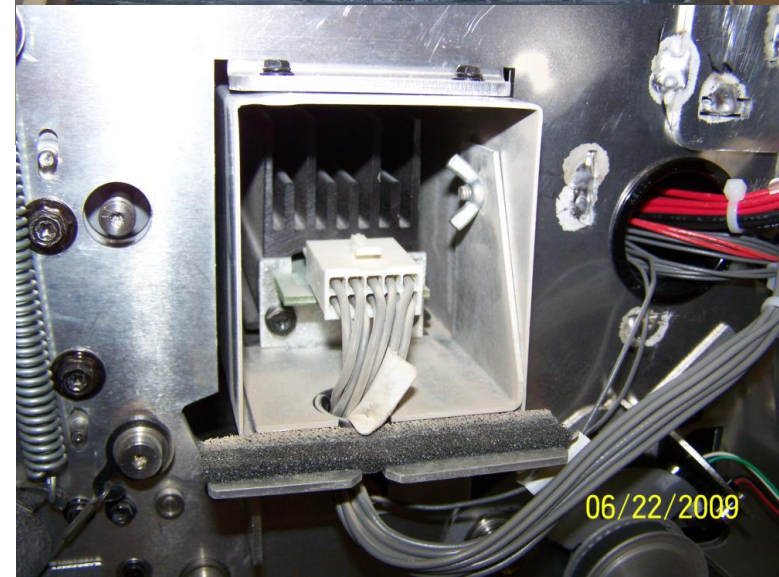
Interior After

- The unit was disassembled after the test and thoroughly inspected for particle ingress
- Minimal contamination was found all below acceptable levels for proper operation

The unit had minimal dust intrusion, well below acceptable levels for proper operation.

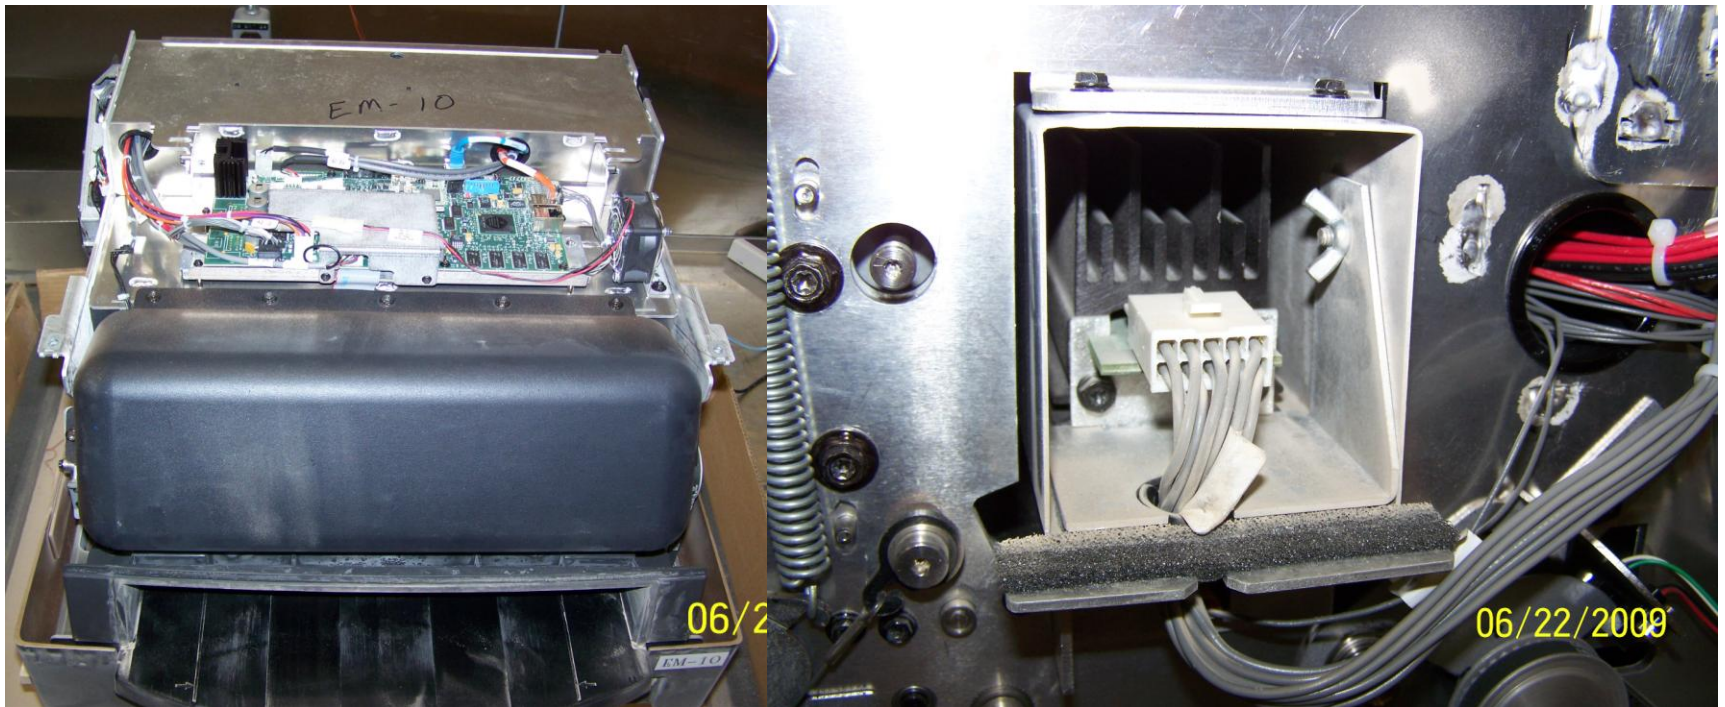
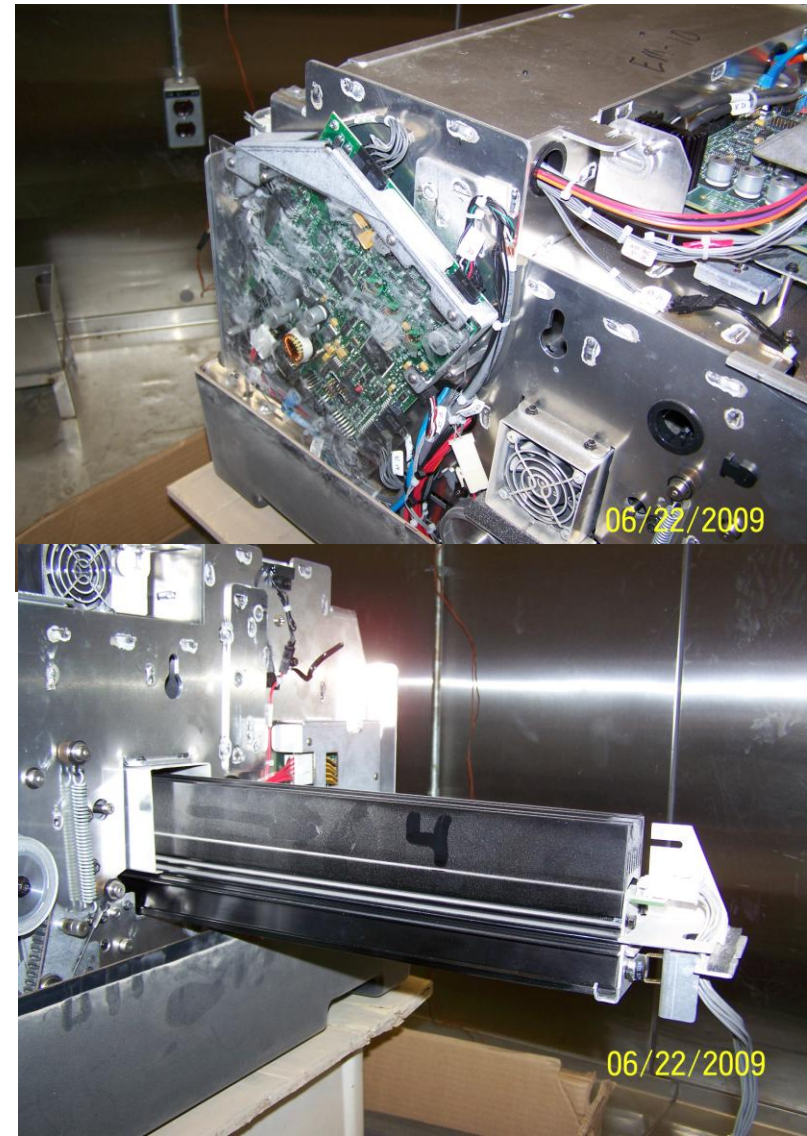
Interior After

- Internal circuit boards and various mechanical assemblies were inspected
- No evidence of significant contamination that could affect the performance of the unit was found

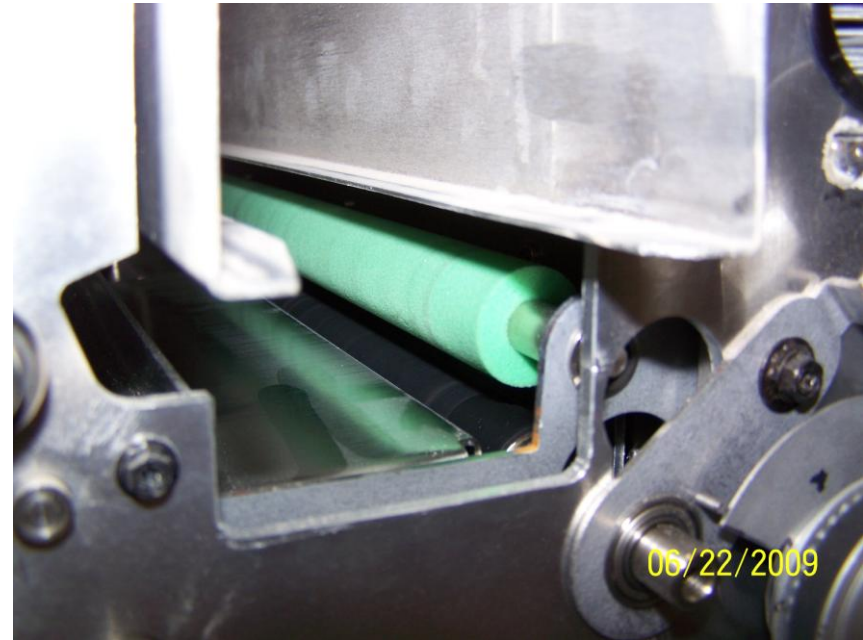
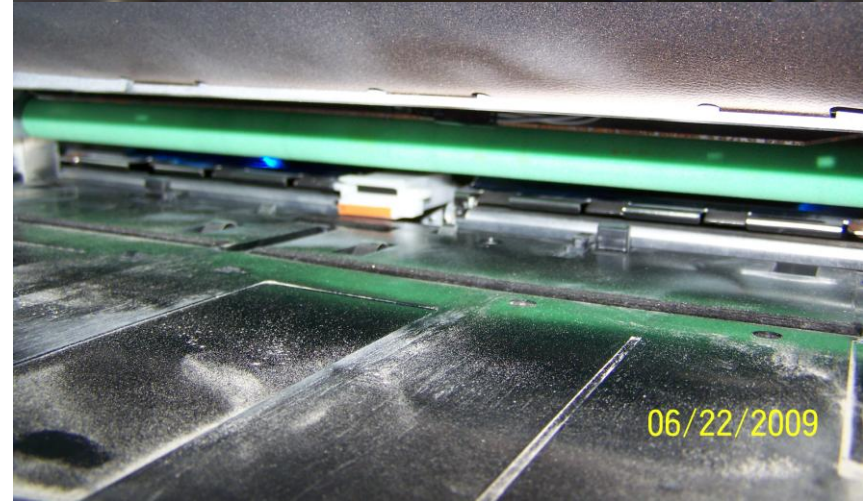
Interior After

- The cassette loading tray, handling mechanisms and erase housing also showed minimum levels of contamination

Well below acceptable levels for proper operation.

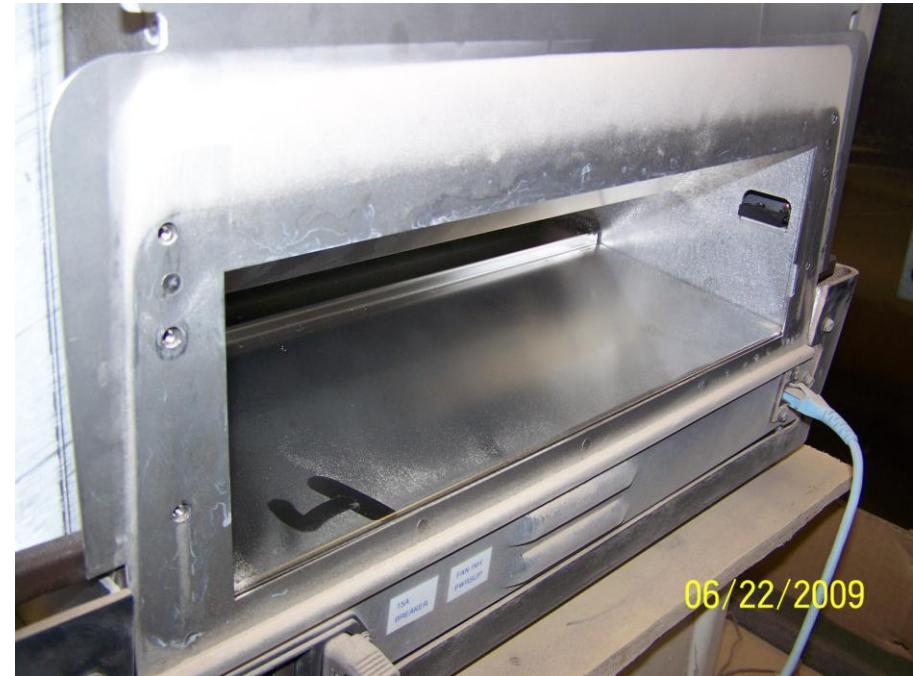
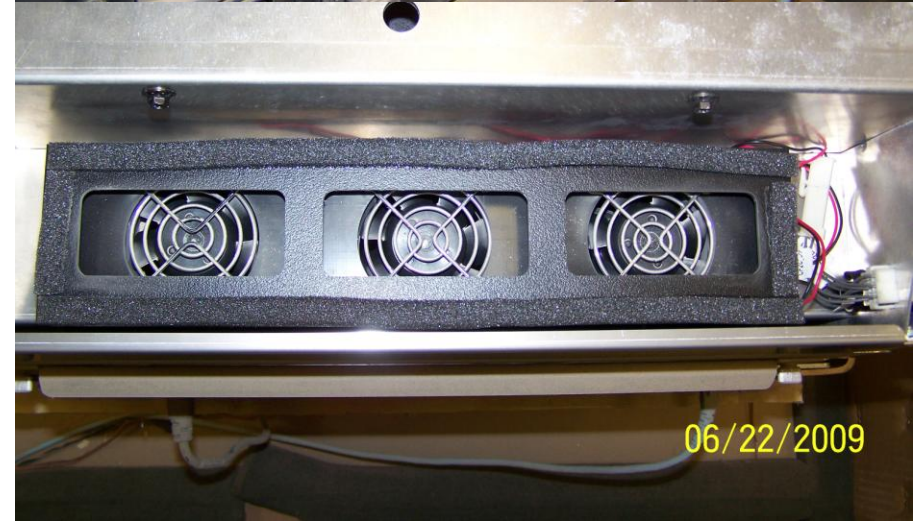
Interior After

- Feed tray (top)
- Cooling fan assembly (bottom)

The unit had minimal dust intrusion below acceptable levels for proper operation.

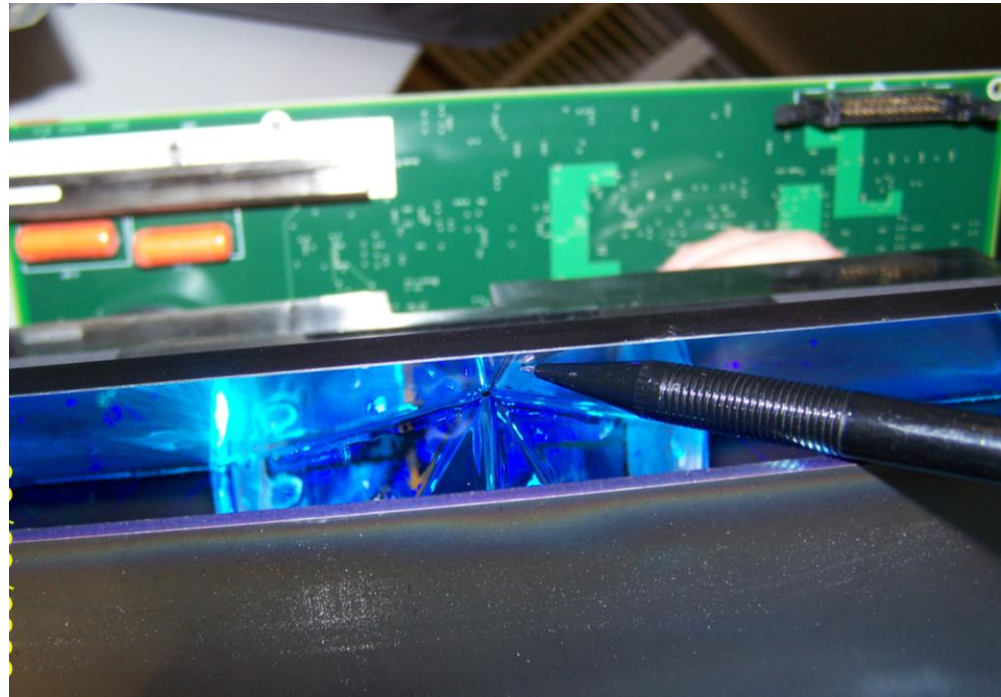
Interior After

- The critical collector was clean following the test

The unit had minimal dust intrusion below acceptable levels for proper operation.
